Effect of Electromagnetic Interference from an Electric Vehicle Tesla Supercharger Station on Implantable Cardioverter Defibrillators.

Ratajczak, Theresa MD. Hussain, Umbreen MD. Aung, Thein MD. Markert, Ronald PhD. Wase, Abdul MD, FACC, FHRS.

Department of Internal Medicine, Wright State University Boonshoft School of Medicine

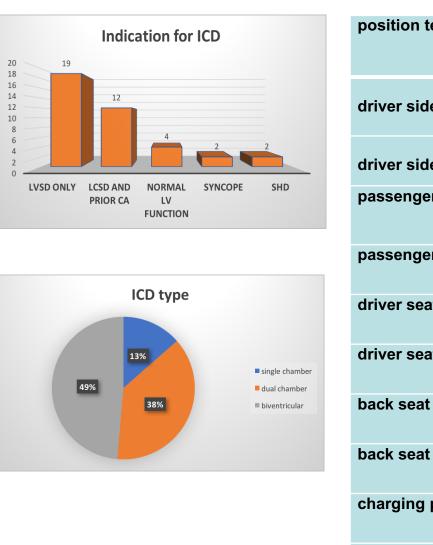
In each position the device and patient were monitored in real time by a certified technician from the manufacturer for any inappropriate sensing and delivery of therapies. A medical magnet was also available at the site of testing as a safety measure.

position tested	Presence of interference
driver side rear high	not detected
driver side rear low	not detected
passenger seat high	not detected
passenger seat low	not detected
driver seat low	not detected
driver seat high	not detected
back seat pass low	not detected
back seat pass high	not detected
charging port low	not detected
charging port high	not detected
